National Transportation Safety Board

Railroad Accident Brief

Accident No.: DCA-06-FR-003
Location: Quantico, Virginia
Date: January 5, 2006
Time: 3:04 a.m. eastern standard time¹
Railroad: Virginia Railway Express train on CSX Transportation property
Damage: \$425,000
Injuries: 9
Fatalities: 0
Type of Accident: Derailment

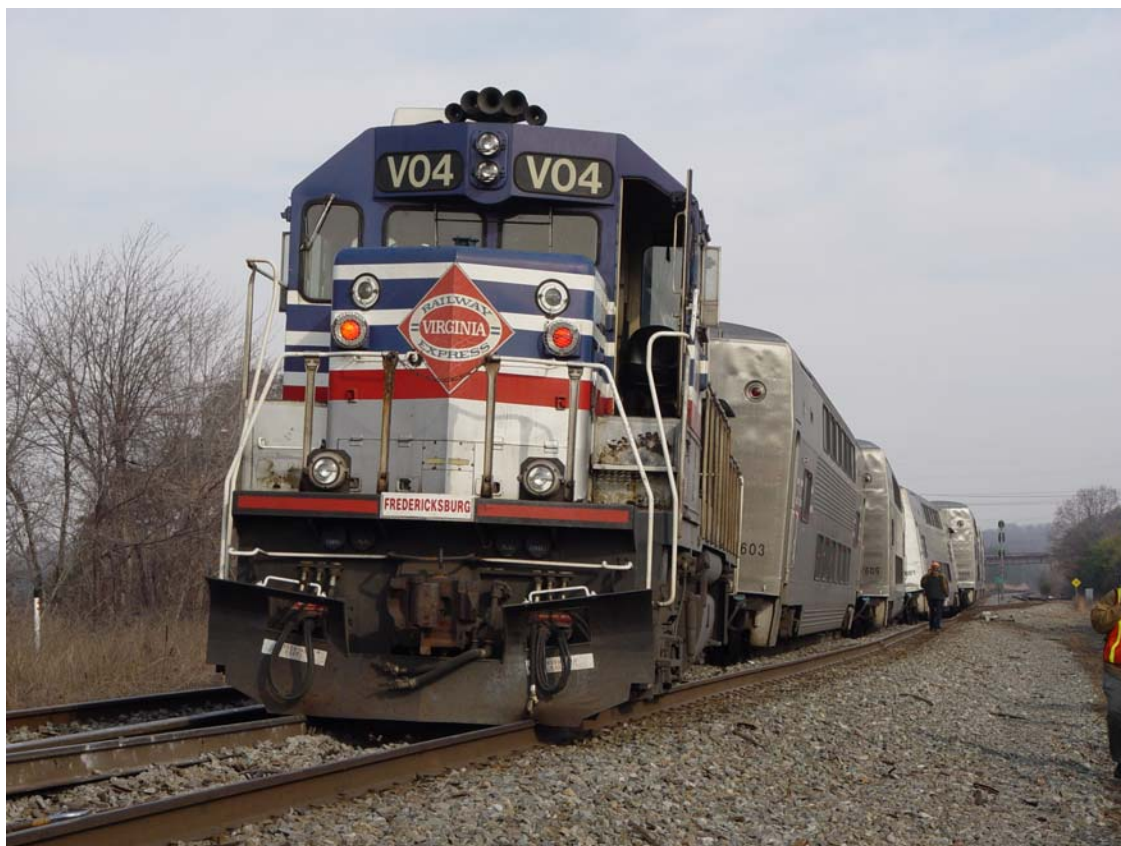
The crewmembers said that the trip had been “uneventful” up to Possum Point. The engineer and conductor stated that they had not seen any track anomalies or felt anything unusual as they left the single main track and traversed the turnout. As the train was moving over the turnout, the fourth car derailed in the switch point area. Because of the resulting damage to the turnout and the misalignment at the frog² area, the fifth and sixth cars and the locomotive derailed when they reached it. The lead car stopped about 800 feet north of the switch point. The derailed equipment remained upright when it came to rest.

Figure 1. Looking north at resting position of train.

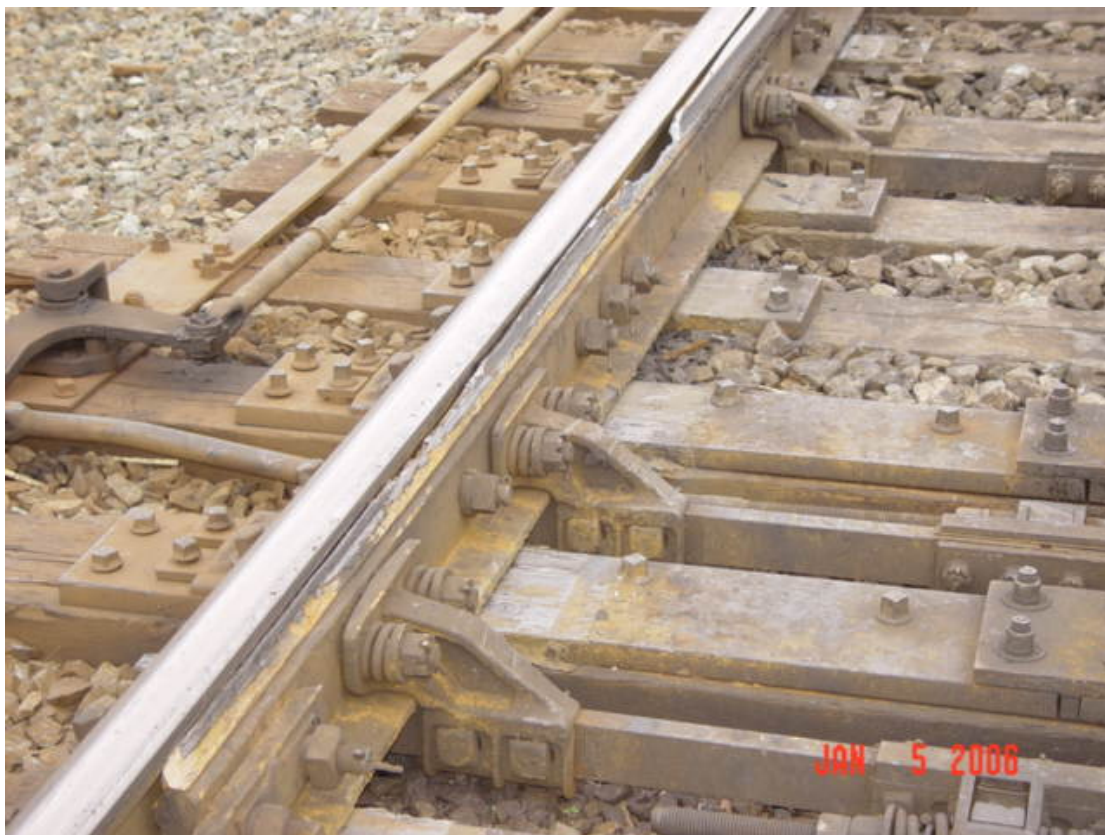
The Possum Point turnout was made of continuous welded rail, 39-foot welded switch points, and stock rails fastened to wooden crossties with appropriate switch apparatus. Investigators found wheel markings that began about 22 inches from the end of the left switch point. The markings continued along the top of the stock rail and “fell down” between the field side of the left switch point and the gage side of the stock rail. The markings continued northward toward the frog. The investigators determined that the lead axle of the fourth passenger car derailed first and, in the process, damaged the track and caused the track structure to shift at the frog. Consequently, when the wheels of the trailing passenger cars and the locomotive reached the same spot, they also derailed.

Figure 2. Looking north at the reverse, or left, switch point, which was the point of derailment.

Before the accident, the left switch point was unusually chipped or worn, and several pieces of the top edge of the switch point were broken. Because the edge was broken, the left wheel of the fourth passenger car had “ramped up” onto the top of the stock rail. After the accident, investigators found that a much larger piece of the switch point, about 66 inches from the end of the switch point, was broken. However, they determined that the break had been caused by the accident; a derailed wheel had fallen between the switch point and stock rail.

The National Transportation Safety Board determines that the probable cause of the January 5, 2006, derailment of Virginia Railway Express train 304-05 near Quantico, Virginia, was an excessively worn and chipped switch point, which caused the lead truck of the fourth passenger car to derail. Contributing to the accident was CSX's delay in replacing a switch point that had been repeatedly identified as deteriorating.

Main track switch points are not to be repaired by any welding process. In the event that it becomes necessary to repair a switch point in an emergency situation, a 10 mph speed restriction must be placed on the turnout until the point is replaced.
